**CULTURAL RESOURCES INVENTORY REPORT  
LABYRINTH CANYON ABANDONED MINE RECLAMATION  
PROJECT,  
EMERY AND GRAND COUNTIES, UTAH**

**Project Title:** Labyrinth Canyon Abandoned Mine Reclamation Project, Emery and Grand Counties, Utah

**Report Title and Date:** Cultural Resources Inventory Report for the Labyrinth Canyon Abandoned Mine Reclamation Project, Emery and Grand Counties, Utah  
November 2004

**Project Description:** Evaluations were made of the historic values of 22 abandoned uranium mine openings slated for closure by the Division of Oil, Gas and Mining's Abandoned Mine Reclamation Program. This cultural resource survey and resulting report were conducted in compliance with Section 106 of the National Historic Preservation Act.

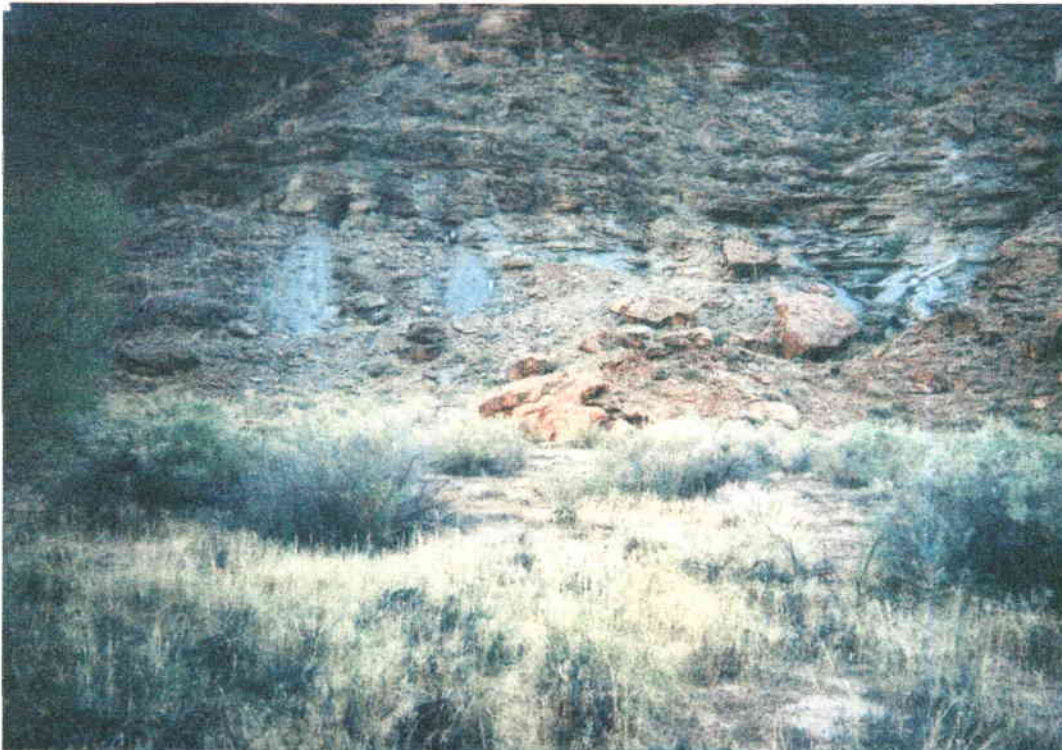
**42Em3346, Features 3-6. View to the southwest.**

Feature 3 (251723HO2) is a mine adit measuring six feet wide by four and one-half feet high. The mine is located within a cul-de-sac of the canyon wall near to Feature 4. The interior is unsupported and extends for approximately 100 feet into highly fractured, jointed sandstone. There is no associated dump. A road accesses the feature.

Feature 4 (251723HO3) is a mine adit measuring six feet wide by four and one-half feet high and with an associated dump. The mine is located within a cul-de-sac of the canyon wall near to Feature 3. The interior is unsupported and extends for an unknown distance into highly fractured, jointed sandstone. The adjacent dump measures 15 feet across, is 25 feet high and contains less than 100 cubic yards of fill. A road accesses the feature between the adit and the dump.

Feature 5 (251723HO4) is a mine adit measuring four feet wide by six and one-half feet high and with an associated dump. The interior is unsupported and extends for approximately 65 feet into highly fractured, jointed sandstone. The adjacent dump measures 30 feet across, is two feet thick and contains only a small amount of fill. A road accesses the feature between the adit and the dump.

Feature 6 (251723HO5) is a mine adit measuring four feet wide by six feet high and with an associated dump. The interior is unsupported and extends for approximately 60 feet into highly fractured, jointed sandstone. The adjacent dump measures 60 feet across, is two feet thick and contains less than 20 cubic yards of fill. A road accesses the feature between the adit and the dump.

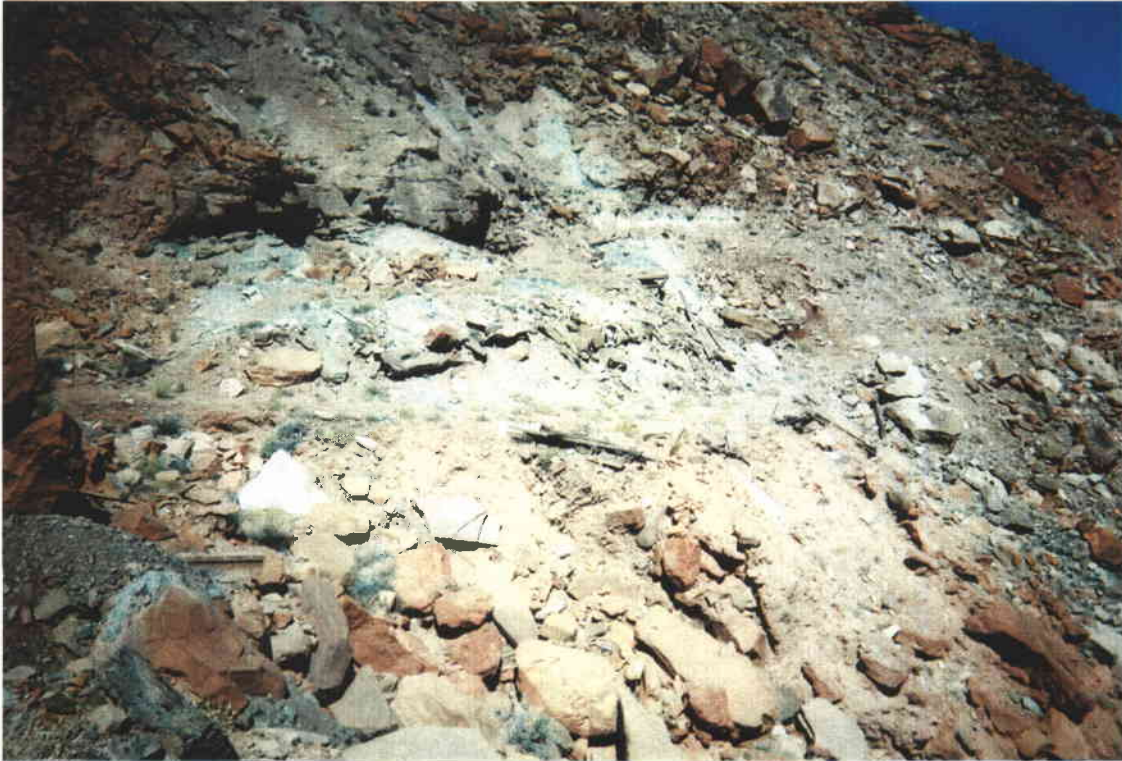
**42Em3347, Features 5 and 6. View to the west.**

Feature 5 (4251725HO1) is a mine adit measuring six and one-half feet wide by ten feet high and with an associated dump. The interior is supported by both square sets and continuous box cribbing and extends for approximately 130 feet into highly fractured, jointed sandstone. The adjacent dump measures 80 feet across, is 15 feet high, and contains approximately 875 cubic yards of fill. Atop the dump are fragments of a rail trestle, scraps of corrugated roofing, and a drill bit; no rails remain. A road accesses the feature between the adit and the dump.

Feature 6 (4251725HO2) is a mine adit measuring nine and one-half feet wide by five feet high. The interior is partially supported by wood props and extends for approximately 20 feet into highly fractured, jointed sandstone where it splits and extends for an unknown distance to both the right and to the left. It is likely that it joins with Feature 5. The adjacent dump is quite dispersed and contains less than 100 cubic yards of spoil. A road accesses the feature between the adit and the dump. Remnants of a small rail trestle are present adjacent to this road.

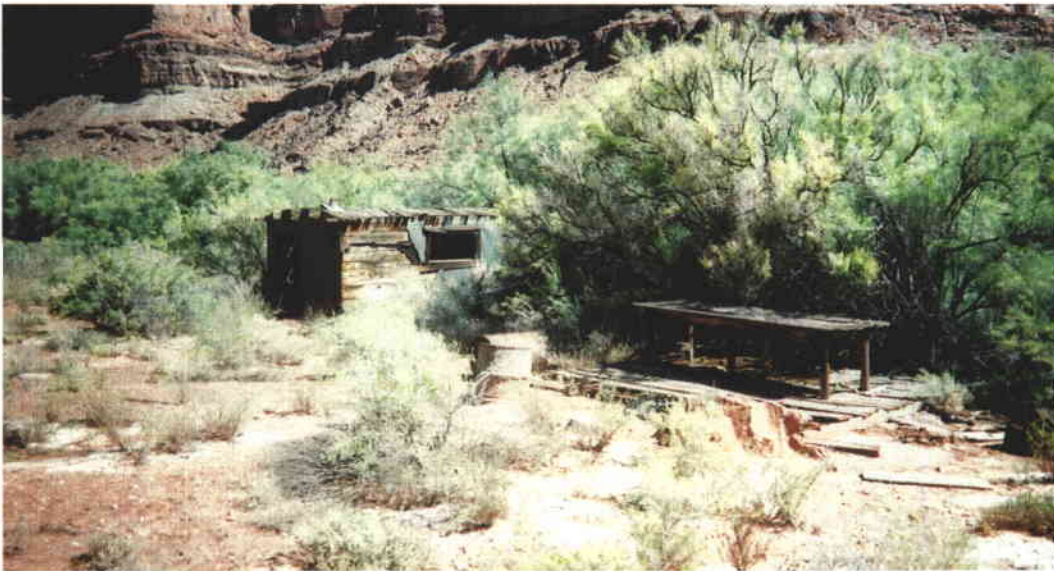
**42Em3347, Features 1 and 2. View to the northeast.**

Feature 1 is a still-standing frame building measuring 16.5 feet east-west by ten feet north-south. The walls are 6.5 feet high and the roof has a curved eight-inch peak formed by bending the roof joists over three spacers. The interior of the building is framed with 2" by 4"s and sheathed with 1" by 12" horizontal planks. These are covered on the exterior with green aggregate tar paper with vertical battens at the seams. There is no evidence of any interior walls or ceiling. The roof support is fabricated from variable-width ½-inch sheathing; these were probably covered with tar paper but none now remains. A stovepipe hole had been cut in the southwest corner of the roof. The floor of the building is unimproved dirt.

A two-foot high by four-foot wide framed window is located on the center of the north and south walls. A framed three-foot by six-foot doorway is located on the north end of the west side, although the door is now missing. Two screened but unframed openings had been cut into the walls at a later date to increase airflow. These are a two-foot wide by 1.25-foot high opening on the north side and a two-foot wide by 2.5-foot opening located on the east side. The interior also has several shelves attached to the frame and fabricated from wooden crates and slats. A tube of Mentholatum shaving cream remains on one of the shelves.

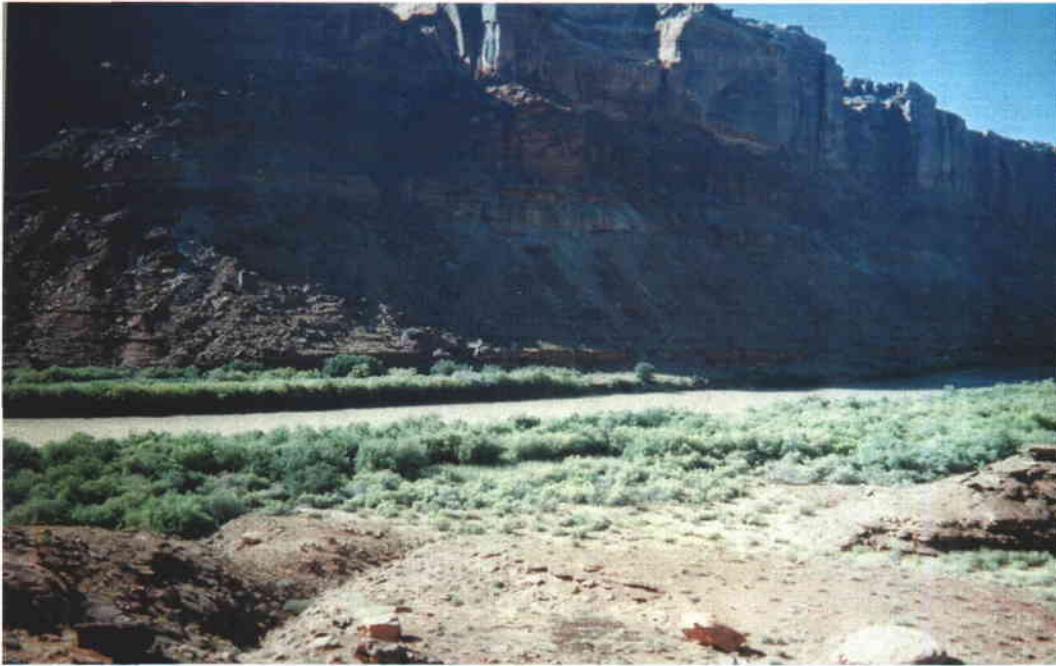
**42Em3348, site overview at upper center of photo. View to the northwest.**

42Em3348 consists of four mine adits that constitute the Denise Mine property, as well as three pieces of abandoned mining equipment (Figure 5). These are located on the steep canyon wall on the west side of the Bowknot Bend of the Green River. An access road connects the mines.

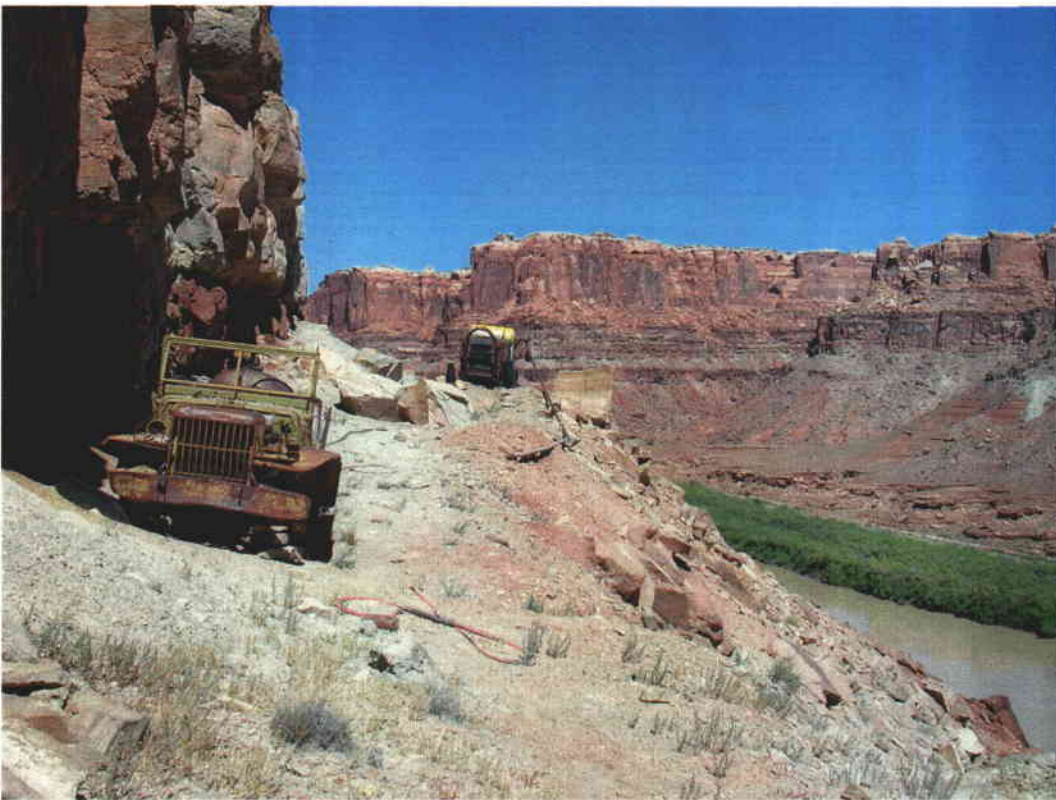
**42Em3348, Feature 5. View to the north.**

Feature 5 consists of two pieces of abandoned equipment located on the access road adjacent to Feature 3. One is a one and one-half ton truck with a 500-gallon tank. This appears to be a surplus WW II-era Willeys truck with the front axel assemblage removed. The Butane Tank Corporation of Los Angeles produced the tank in 1952. The other piece of equipment is a one-ton truck with a compressor. The truck has had its top cut off and a towing apparatus welded to the front. The Young Radiator Company produced the compressor in 1953.

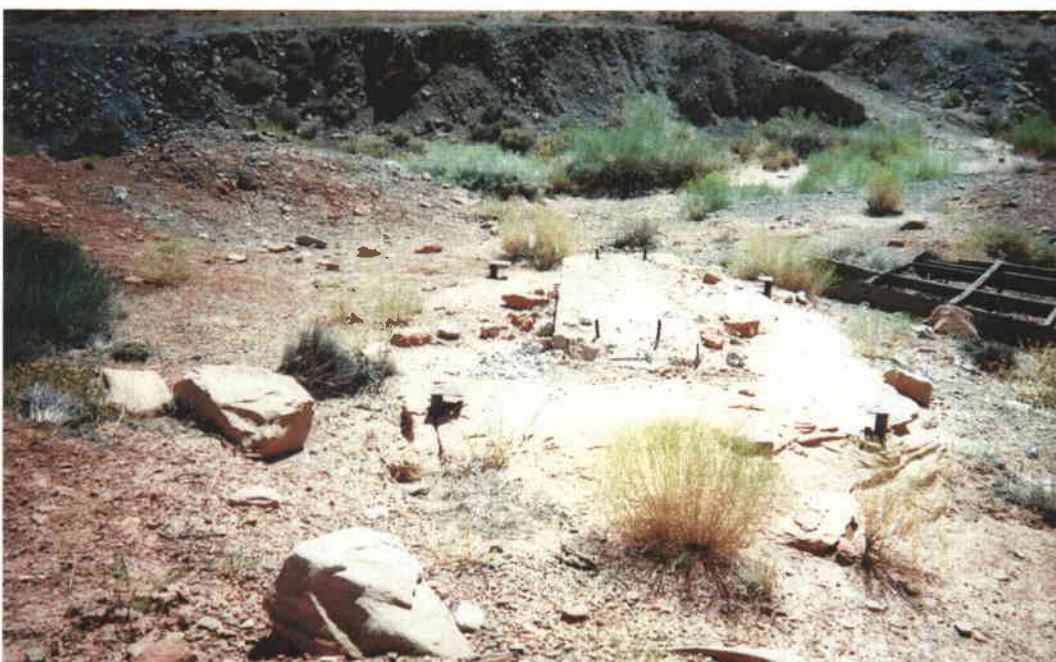
**42Gr3530, Feature 8. View to the southeast.**

Feature 8 is a concrete machine mount located on a slab of exposed sandstone bedrock. The slab is fairly crude and measures six feet east-west by 2.25 feet north-south. The slab is nine inches high on its east side and three inches high on the west. The slab has been attached to its rock foundation by sections of rebar pounded into the rock. Four  $\frac{3}{4}$ " threaded screws extend up three inches from the slab to form a rectangle measuring five feet east-west by one foot north-south.

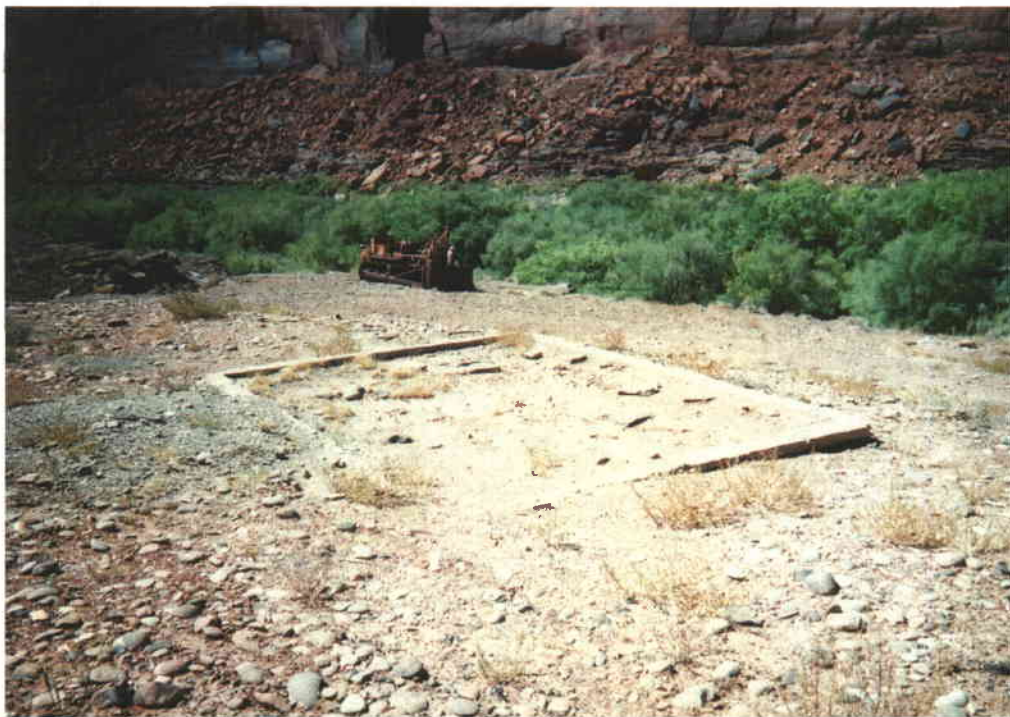
**42Gr3530, Features 2 and 3. View to the southwest.**

Feature 2 is an abandoned bulldozer located 125 feet to the southwest of Feature 3. This is an Allis Chalmers D14 Diesel equipped with a large winch produced by the Pacific Car & Foundry Company of Renton Washington. One of the track treads had been badly damaged.

Feature 3 is a poured concrete foundation footing measuring 16.5 feet north-south by 12 feet east-west. The footing is eight inches wide and is elevated between one and six inches above the ground surface. At four-foot intervals, ½ inch bolts protrude from the footing. Curiously, there is almost no evidence of a superstructure. It is possible one was never built or that it was salvaged whole. Just to the south is a 12-foot diameter depression with approximately 20 bayonet-opened sanitary cans on the inside. Other artifacts in the vicinity include more sanitary cans, aluminum sardine cans, and clear glass fragments. A metal bed frame and a Serval gas refrigerator identical to the one identified at feature 6 are also present. This type of refrigerator was produced between the early 1950s and 1965.

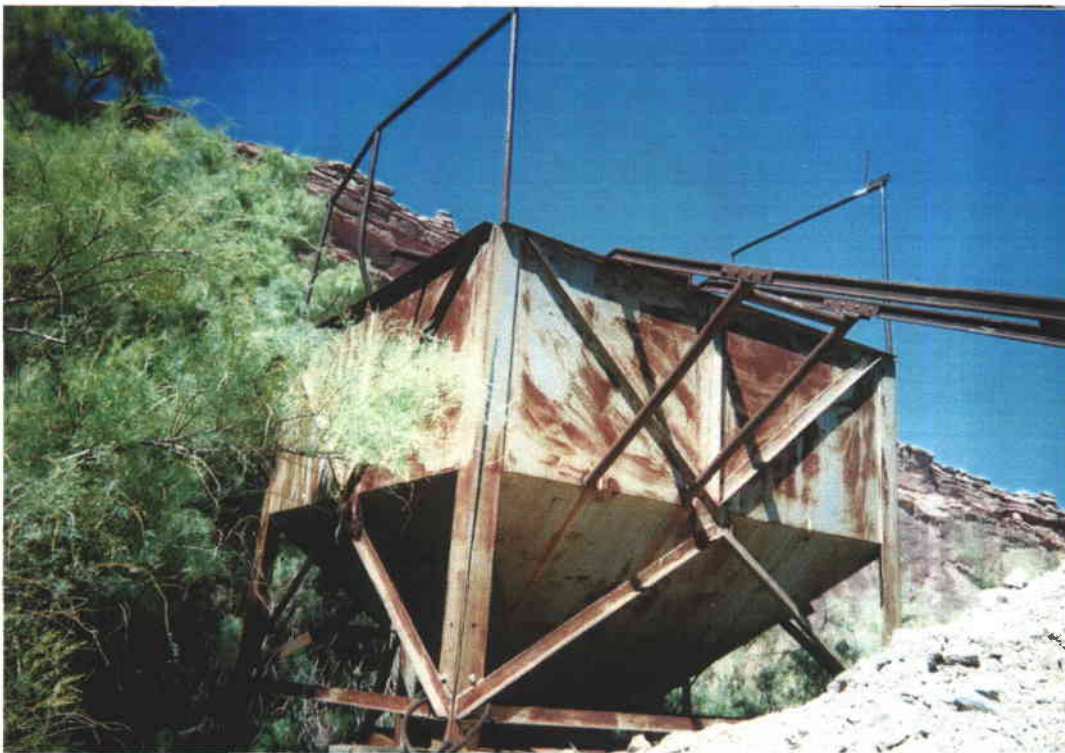
**42Gr3530, Feature 1, View to the northwest.**

Feature 1 is a load-out facility located adjacent to a road and on the edge of the Green River floodplain. The sheet steel hopper appears to have been manufactured although no nameplate was found. It measures ten feet square and is eight feet high. A nine-foot high superstructure fabricated from segments of six inch and two inch angle iron supports the hopper. A set of narrow gauge mine rails runs to the top of the hopper, being mostly supported by an adjacent spoil pile that is approximately 40 feet in diameter and 18 feet high. The downhill (road) side of the spoil pile is retained by 2" by 12" planks held in place by poles, 3" by 6" beams, wire rope, and the support for the hopper. At the top of the hopper, segments of rail and pipe have been crudely welded to provide additional support and a four-foot high railing. The hopper was partially held in place by two segments of one-inch wire rope that connected the hopper to the sandstone ridge to the east and was held in place by embedded drill bits. One section of wire rope still supports the hopper; the other has been severed. This feature is located in an area of thick floodplain vegetation comprised of tamarisk and willow. Artifacts or other features may be located in this vicinity but are not currently visible.

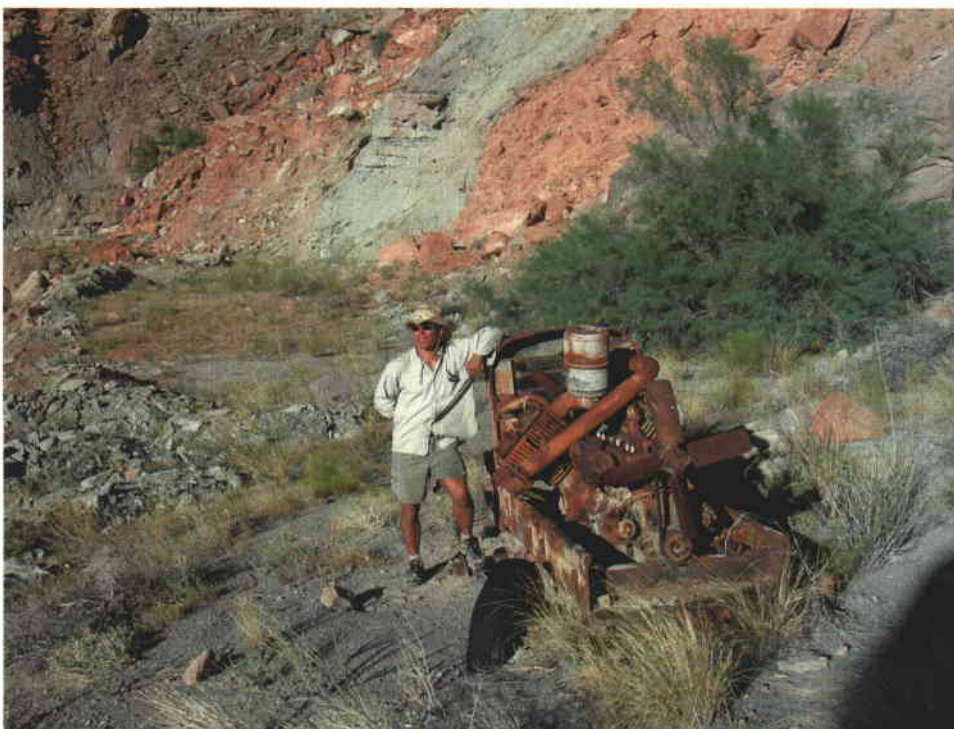
**42Gr3531, Feature 3. View to the north.**

Feature 3 is a portable compressor that had been abandoned at the extreme southern end of the site. The vehicle, which has a Hercules Engine, had been sold by the Shaw Sales and Service Company of California. The vehicle supports a Chicago Pneumatic air compressor with a 7-4X5 Simplex Valve engine.

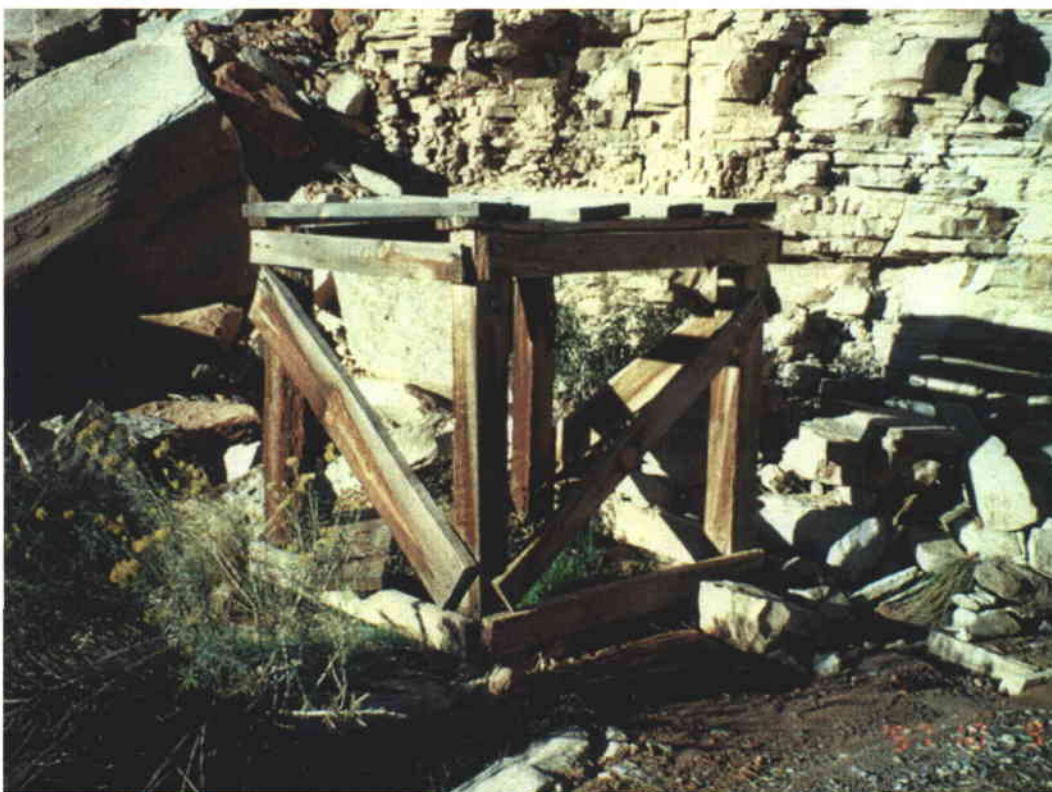
**42Gr3532, Feature 3. View to the northeast.**

Feature 3 is a frame box made of 6" by 6" and 2" by 6" planks with a roof made of 2" by 4"s. The entire box forms a five-foot cube. This may have been used in the mine to provide protection for the miners while working on the mine face.
